AFFDL-TR-71-126

ADVANCED COMPOSITE JOINTS; DESIGN AND ACOUSTIC FATIGUE CHARACTERISTICS

Northrop Corporation

TECHNICAL REPORT AFFDL-TR-71-126

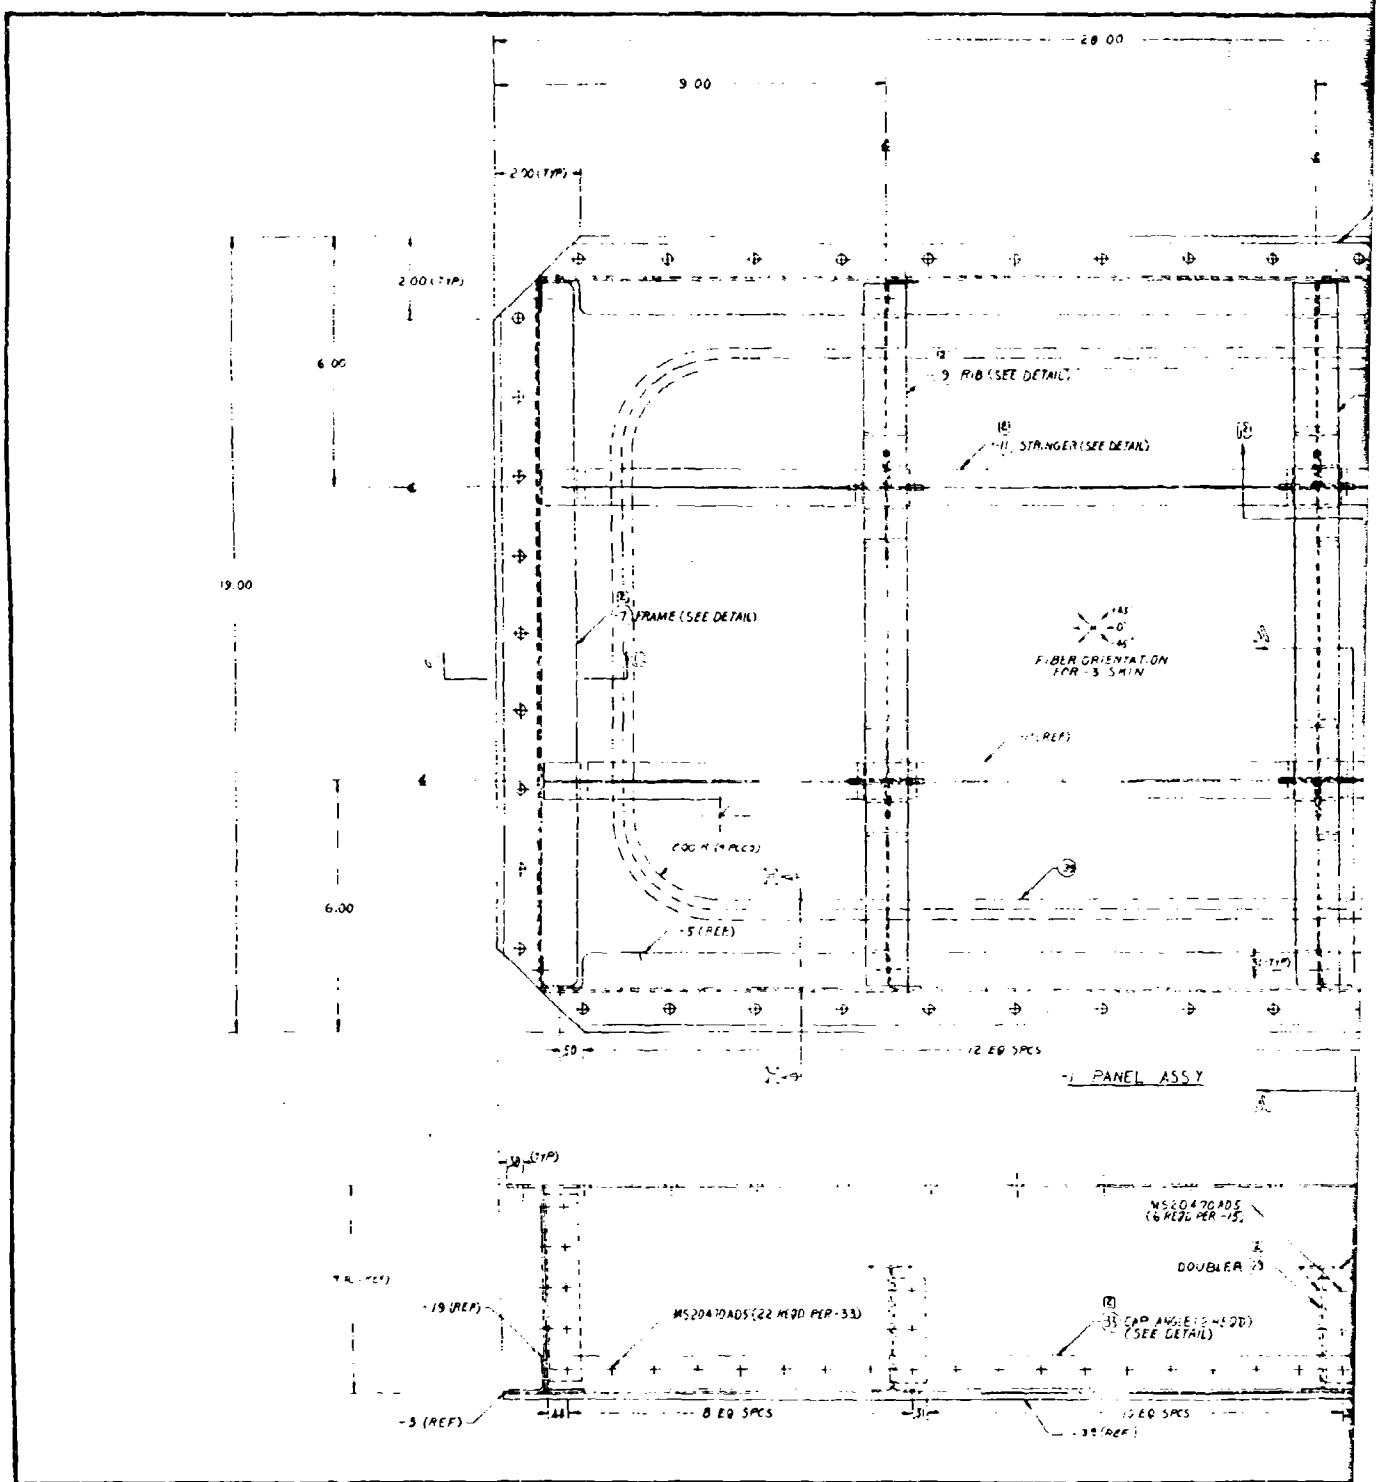
FIGURE 3. PANEL A-GG-B-1

The design of the initial test panel, A-GG-B-1, is given in Figure 3 (Drawing ACD-G-237). Panel A-GG-B-1 was manufactured and during the acoustic test experienced a premature acoustic fatigue failure. The panel design was then modified according to Drawing ACD-G-238 (Figure 4) and panels A-GG-B-2 and A-GG-B-3 were manufactured according to the modified design that is discussed in detail in Section III. 1. (b). Panels A-GG-B-2 and A-GG-B-3 were subjected to approximately 10^8 cycles (the predetermined runout point) without experiencing an acoustic fatigue failure in a panel test section.

INSPECTION OF PANEL A-GG-B-1 AS MANUFACTURED. After the cure was completed, it was noted that the skin had a noticeable oil can in the center bay. The oil can was attributed to residual stresses resulting from the bonding operation.

4. Manufacture a stepped graphite-epoxy doubler (Figure 14) to replace the glass doubler (Section H-H of Figure 3). The purpose of replacing the glass doubler with the graphite-epoxy doubler was to guard against the mismatch of thermal coefficients of expansion of the skin and doubler of panel A-GG-B-1 when the bonding between these two items is conducted at 250F. The alternate approach of using the glass doubler and bonding the glass doubler to the skin with a room temperature curing adhesive was rejected, since the lower strengths of room temperature curing adhesives might lead to the initial acoustic fatigue in the fixture section. The length of the final step of the graphite-epoxy doubler was chosen to be at least as great as one-half the width of the flange of the I-beam sections in order to reduce the likelihood of a fatigue failure at the junction of the unsupported skin and the peripheral doubler. Furthermore, a 4.00-inch radius (in place of the 2.00-inch radius) was proposed for the corners of the graphite-epoxy doubler of panel A-GG-B-2 to guard against corner cracks.

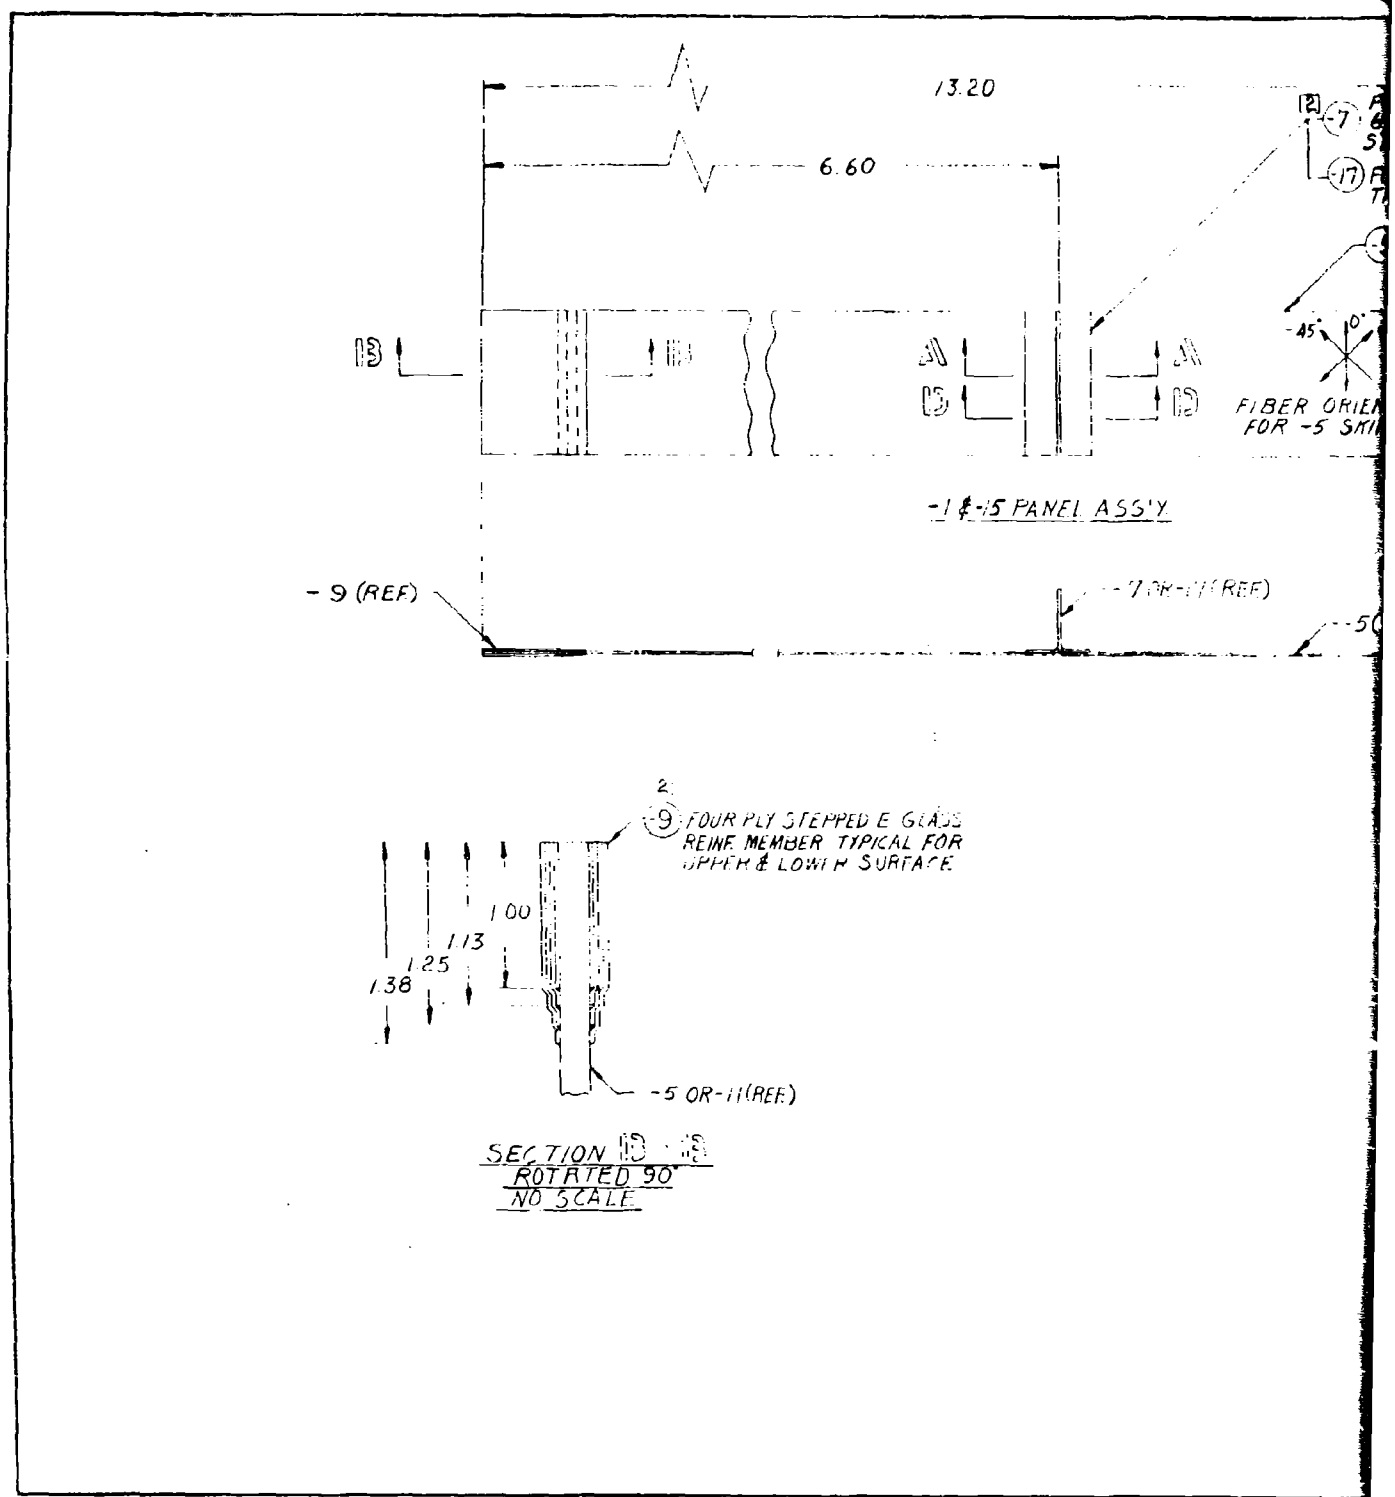
FIGURE 22. GRAPHITE-EPOXY SHAKER TEST SPECIMENS (BONDED SPECIMENS)

Several Candidate A-2 type specimens with graphite-epoxy skins bonded to graphite-epoxy doublers were fabricated using the design with the 13.20 inch length in Figure 22. During the shaker test of the first specimen with the two ends and the central tee section clamped, it was apparent that the design had resulted in a specimen that was too stiff to enable fatigue tests to be conducted at sufficient excitation levels to obtain S-N curves. Therefore, the decision was made to reduce the overall length of all the fabricated specimens by sawing off the glass doublers at the ends of the specimens that were already fabricated and to clamp the specimens only at the stiffener at the center of the specimen. The design change was satisfactory and resulted in the manufacture and fatigue test of shaker specimens without glass doublers at the ends. The tests of the shaker specimens resulted in the establishment of S-N data and curves that are reported in Section VI.

The -23 titanium alloy doublers (of Figures 22 and 23) were bonded to the shaker specimens with EC 2216 adhesive rather than FM-123-2 adhesive in order to utilize a room temperature curing adhesive. The EC 2216 adhesive was adequate in transferring the relatively low skin stresses from the shaker test fixture to the shaker specimens. A photograph of a shaker specimen with the graphite-epoxy skin and stiffener prior to the bonding of the -23 titanium alloy doubler is shown in Figure 25. A photograph of the upper surface of a riveted shaker specimen after strain gaging is in Figure 26 and a photograph of the lower surface is in Figure 27.

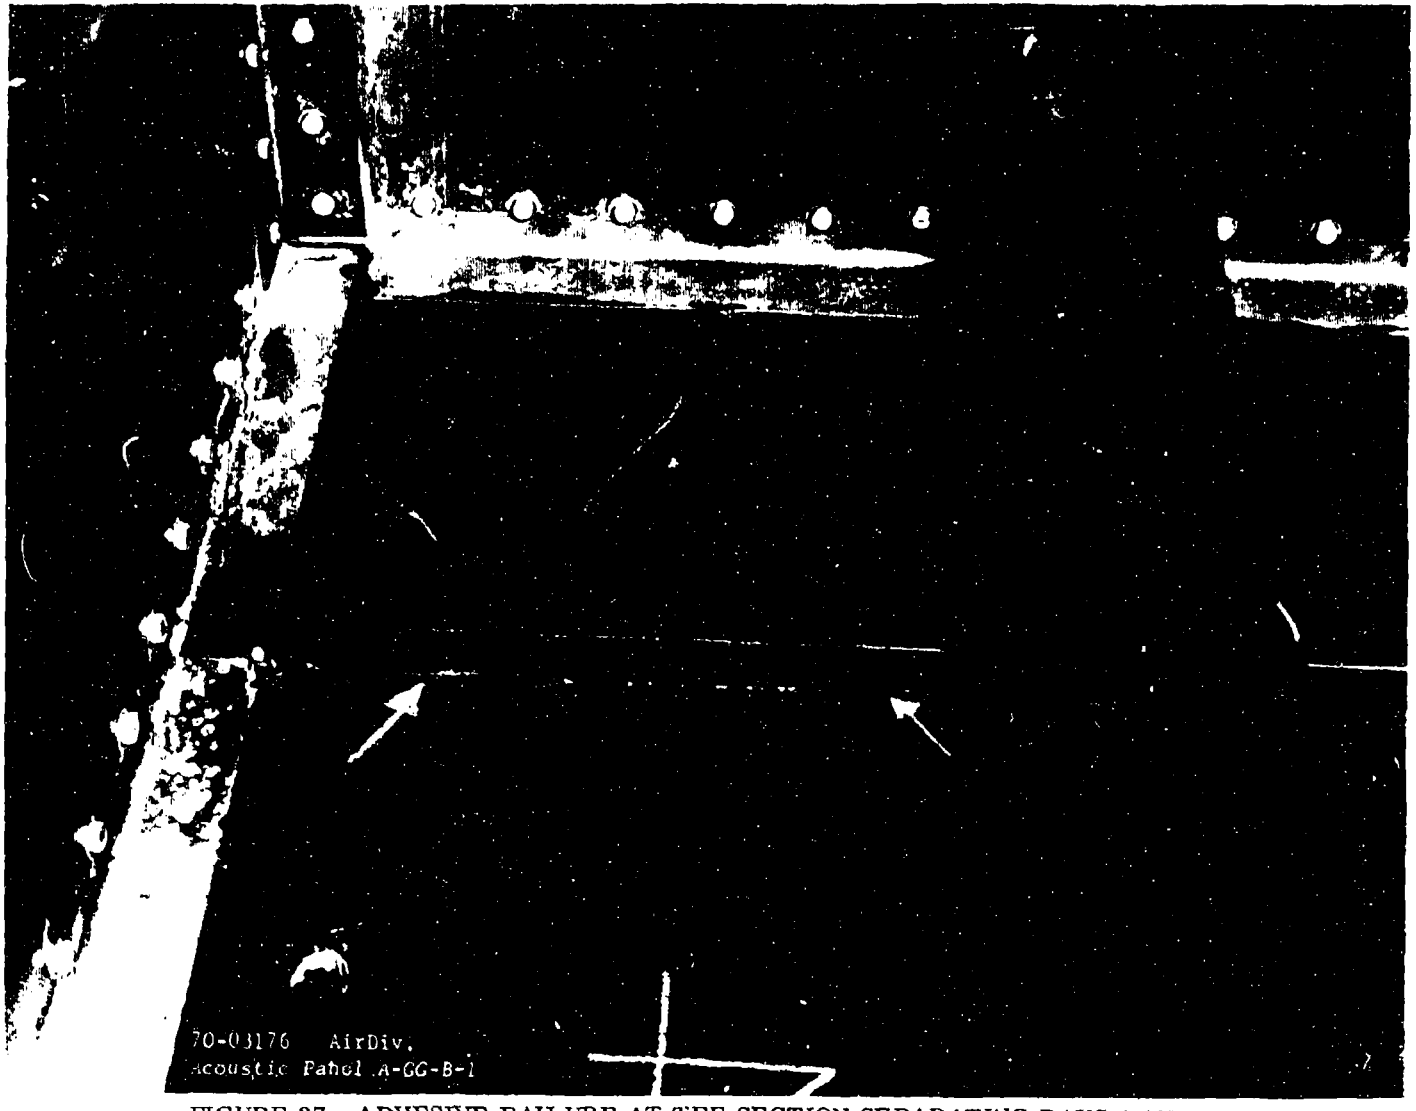
FIGURE 37. ADHESIVE FAILURE AT TEE SECTION SEPARATING BAYS 4 AND 7

FIGURE 38. TEE SECTION FAILURE BETWEEN BAYS 2 AND 5

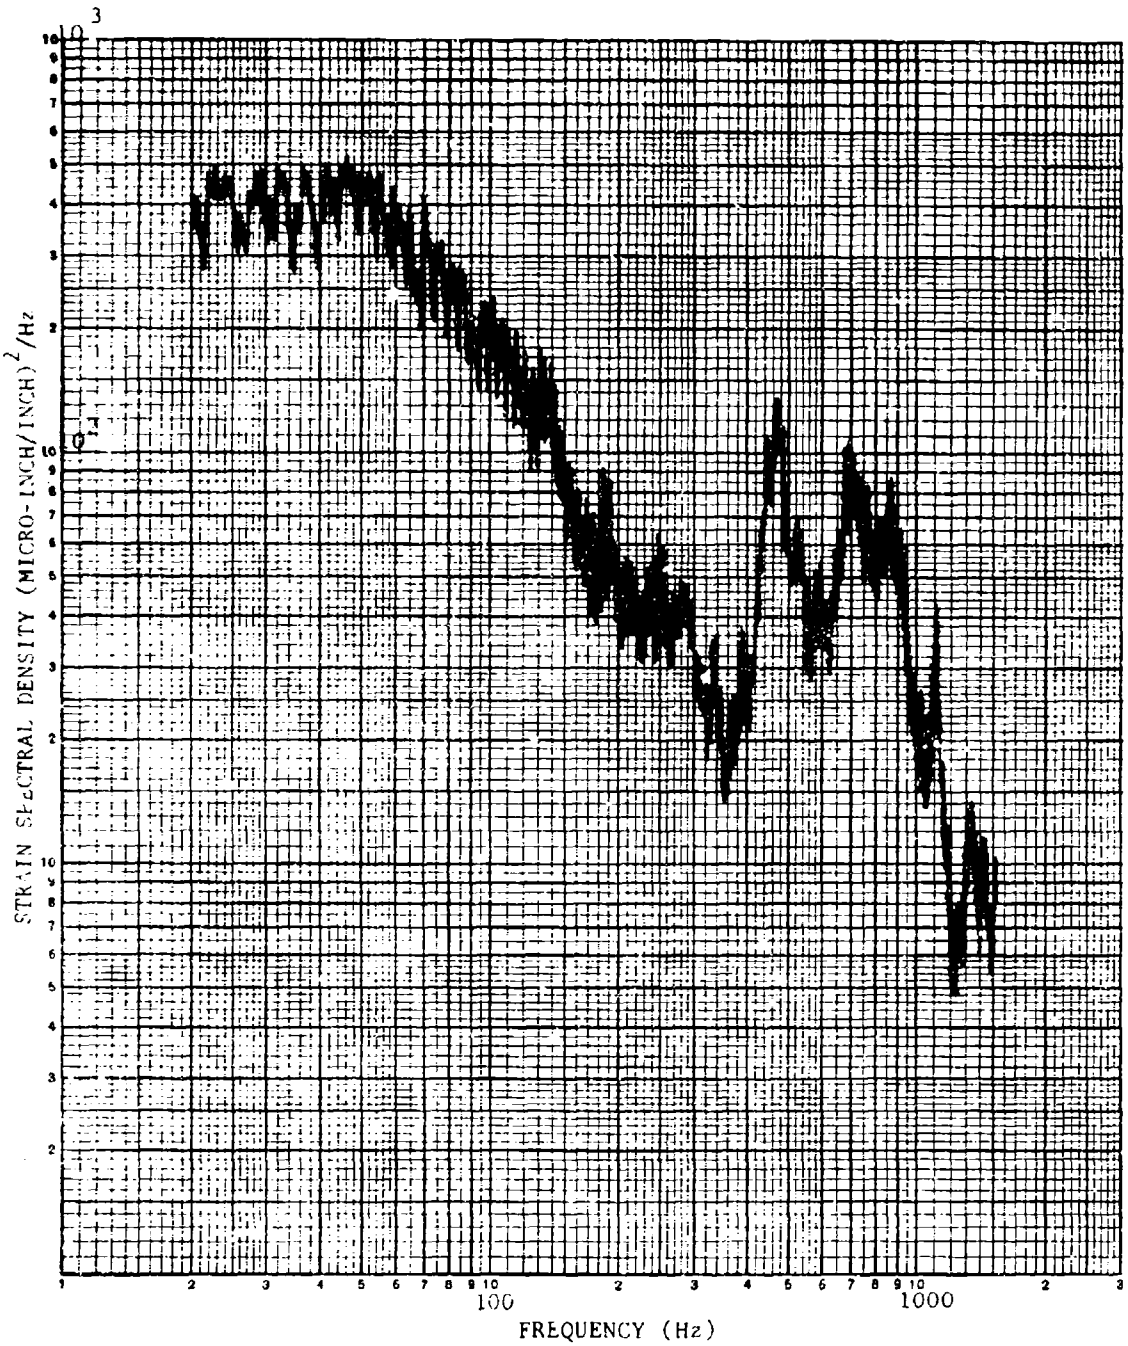
Gage 2. Run 5 (148 db).
Rms strain = 320 micro-inch/inch

FIGURE 43. STRAIN GAGE NO. 2 RESPONSE WITH OIL CANNING AT 148 DB SPL

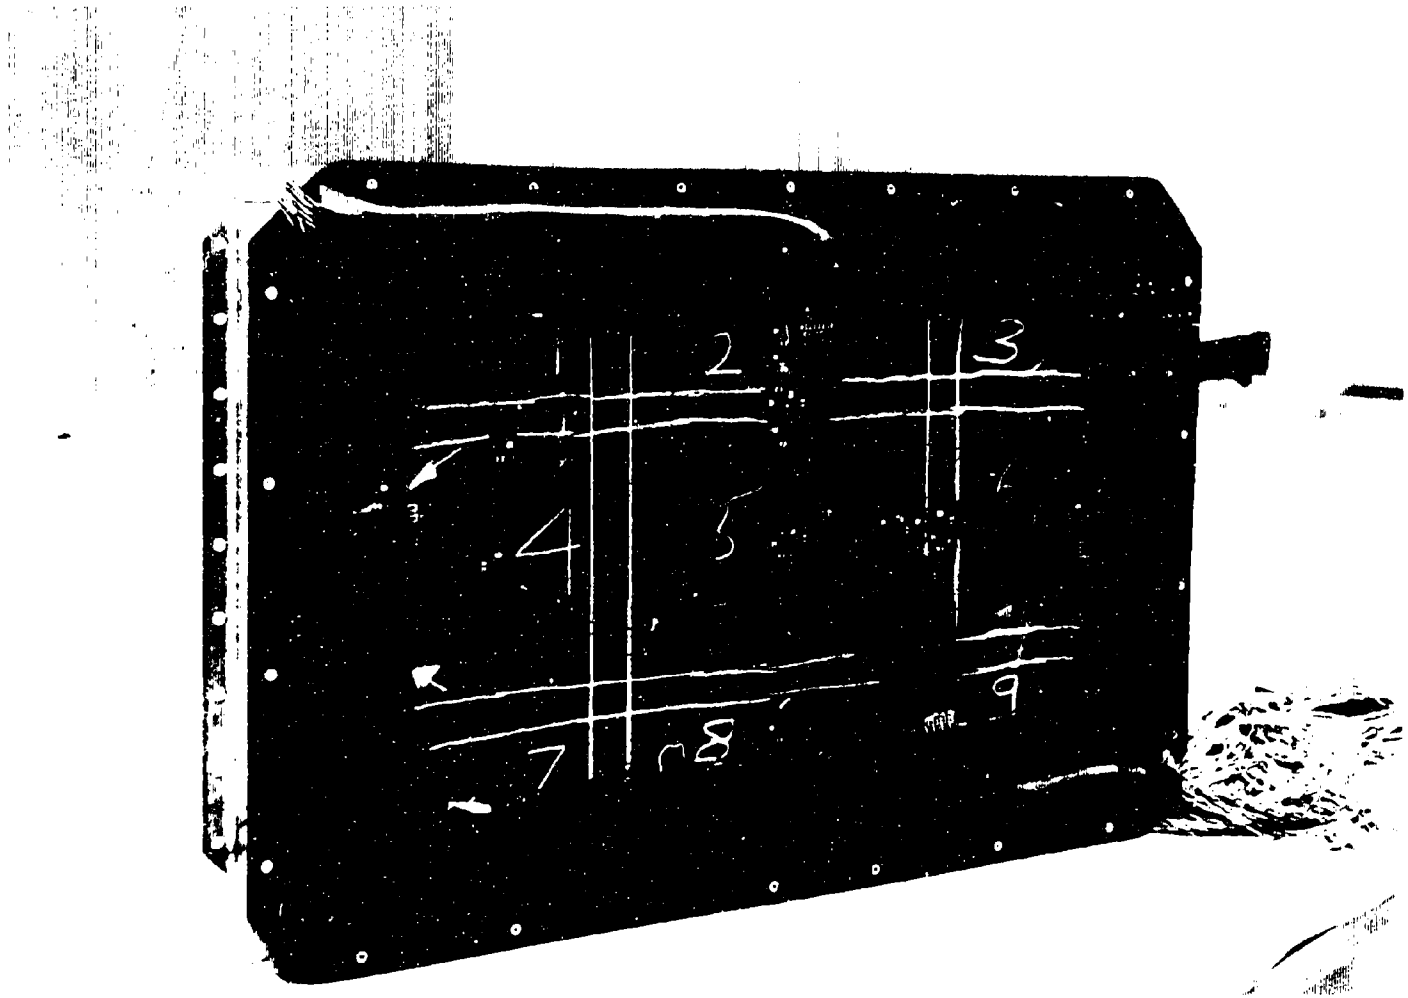
FIGURE 53. ADHESIVE FAILURE (BETWEEN ARROWS) IN BAY 4 OF PANEL A-GG-B-2

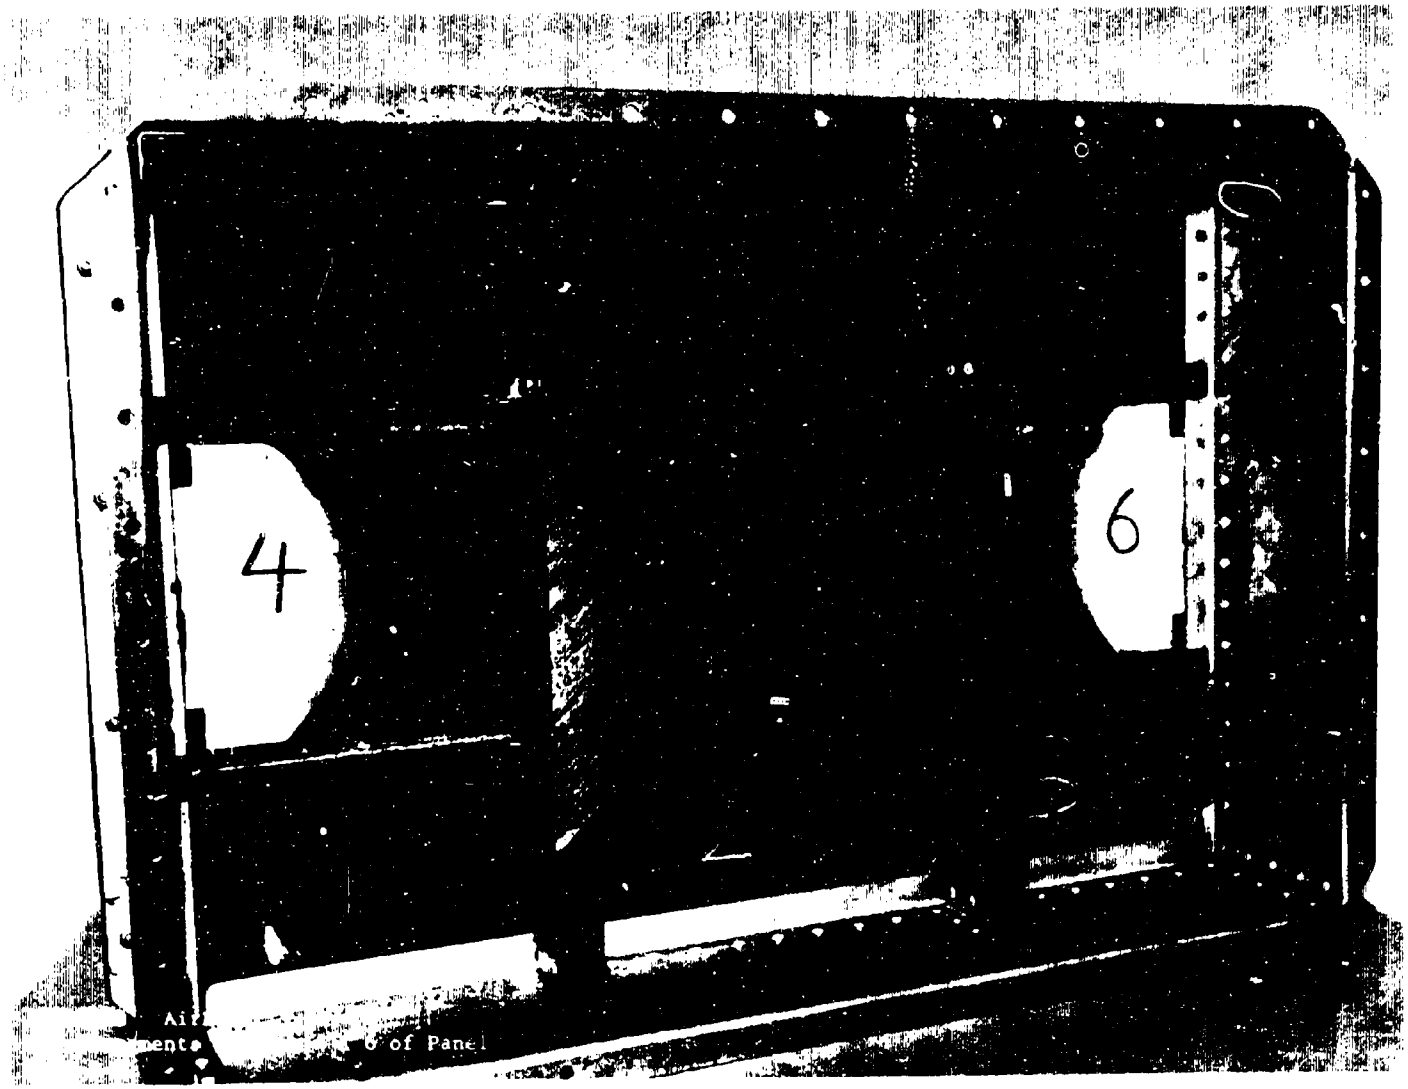
FIGURE 54. DOUBLERS IN BAYS 4 AND 6 ADDED TO PANEL A-GG-B-2

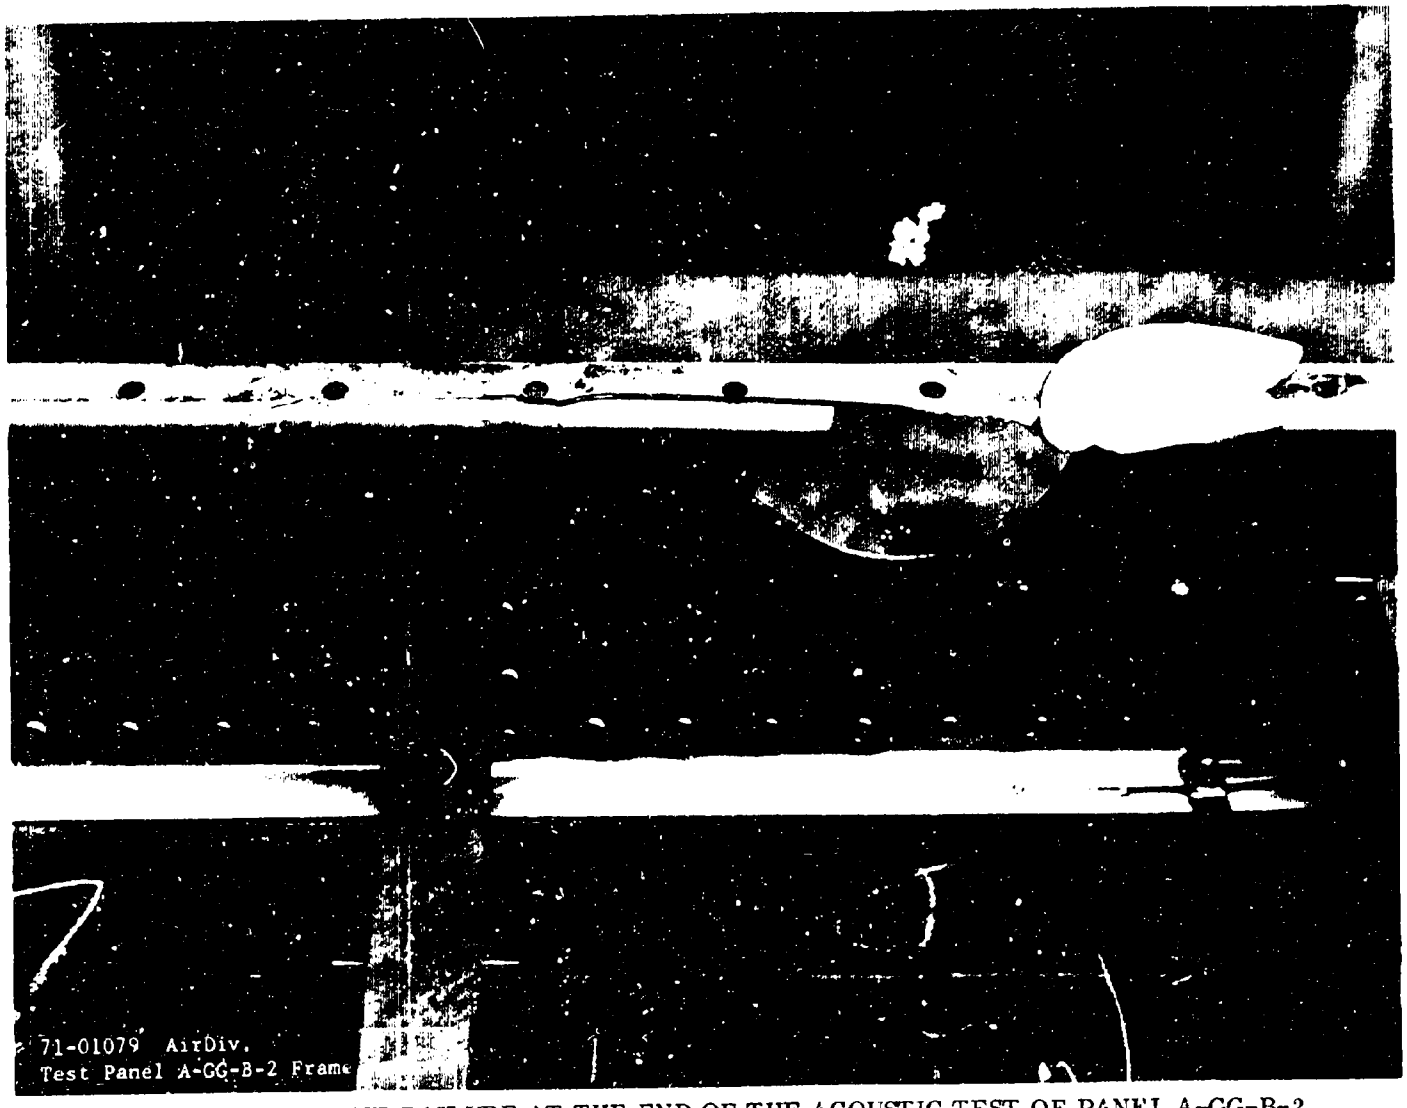
FIGURE 55. FRAME FAILURE AT THE END OF THE ACOUSTIC TEST OF PANEL A-GG-B-2

Glass doublers (Figure 18) were bonded around the periphery of the titanium alloy frame to prevent a frame failure such as had occurred near the end of the acoustic test of panel A-GG-B-2.

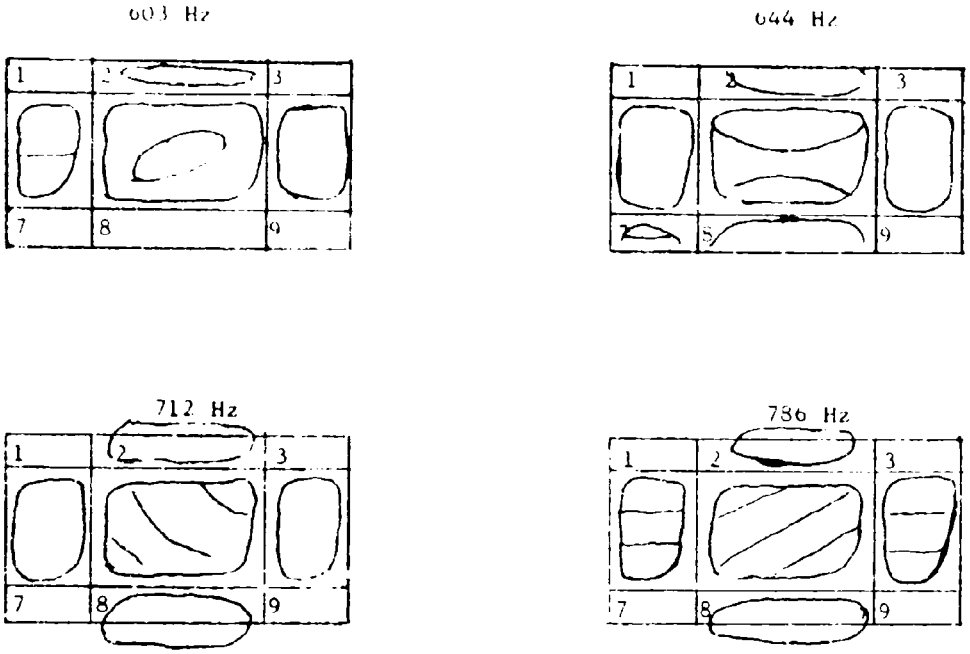
FIGURE 68. NODAL LINES UNDER LOUDSPEAKER EXCITATION OF PANEL A-GG-B-3 (Continued)

(At the 712 and 786 Hz natural frequencies, the nodal lines for bays 2 and 8 include areas of the graphite-epoxy edge doubler of the panel)

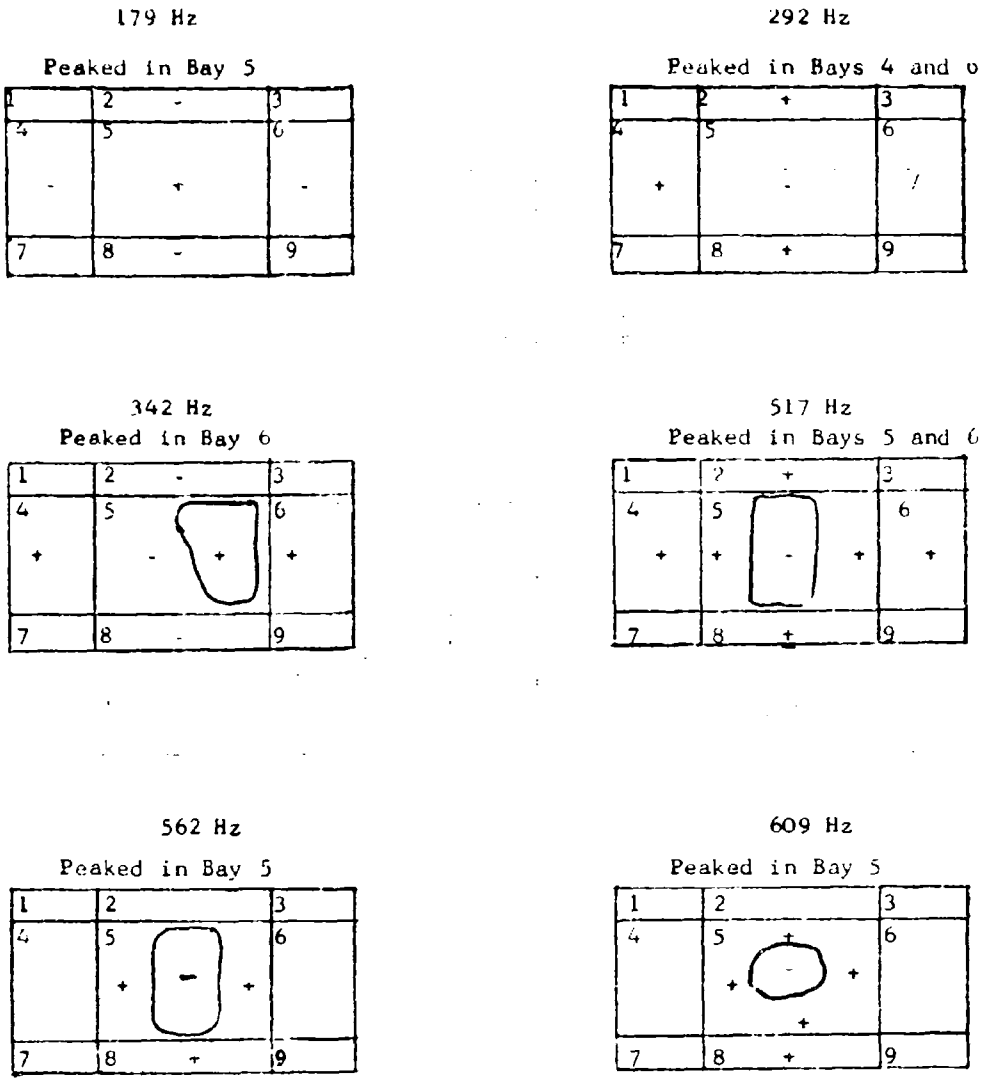
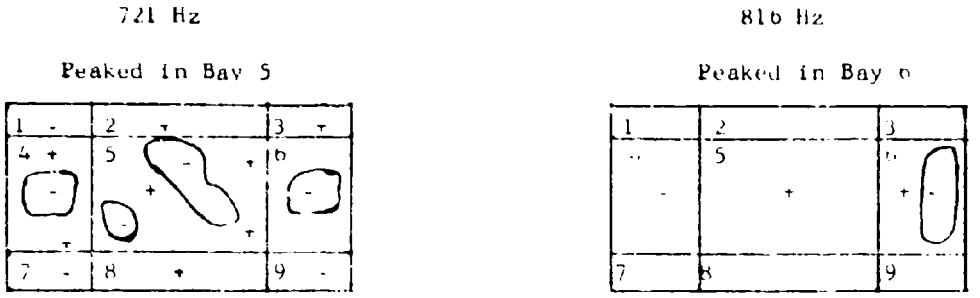
FIGURE 69. MODAL SURVEY OF PANEL A-GG-B-3 WITH NODAL LINES ESTIMATED WITH ACCELEROMETER SIGNALS

In Figure 69 only the lower mode shapes are shown and these were estimated with the use of the roving accelerometer to determine phase changes.

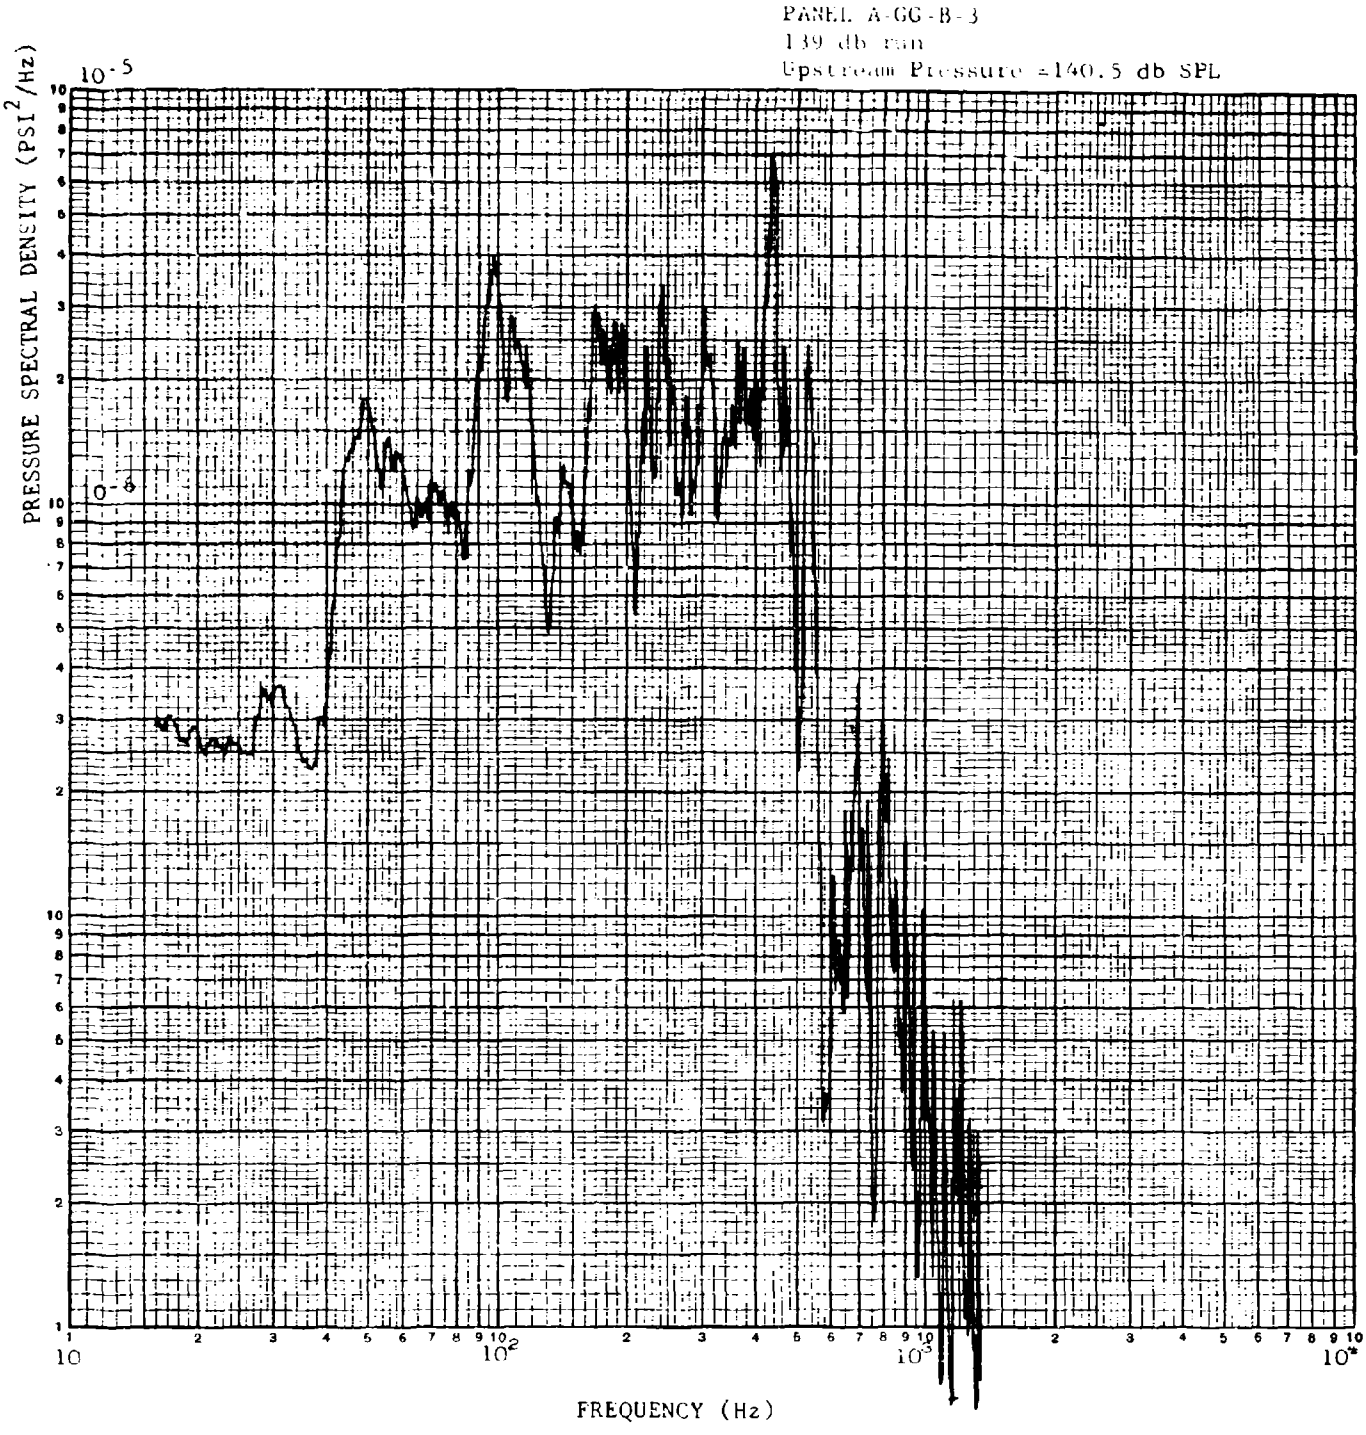
FIGURE 71. PRESSURE SPECTRAL DENSITY

From an examination of Figures 71 and 73 during the 139 db SPL run, there are peaks, similar to the resonant response of single degree of freedom spring-mass-dashpot systems, of the strain spectral density at strain gage No. 2, at several natural frequencies (with the lowest natural frequency at 200 Hz). The rms strain response in Figure 73 in the neighborhood of 200 Hz is significantly higher than the rms response in the neighborhood of 100 Hz although the PSD of the excitation pressure in Figure 71 is somewhat higher in the neighborhood of 100 Hz than in the neighborhood of 200 Hz.

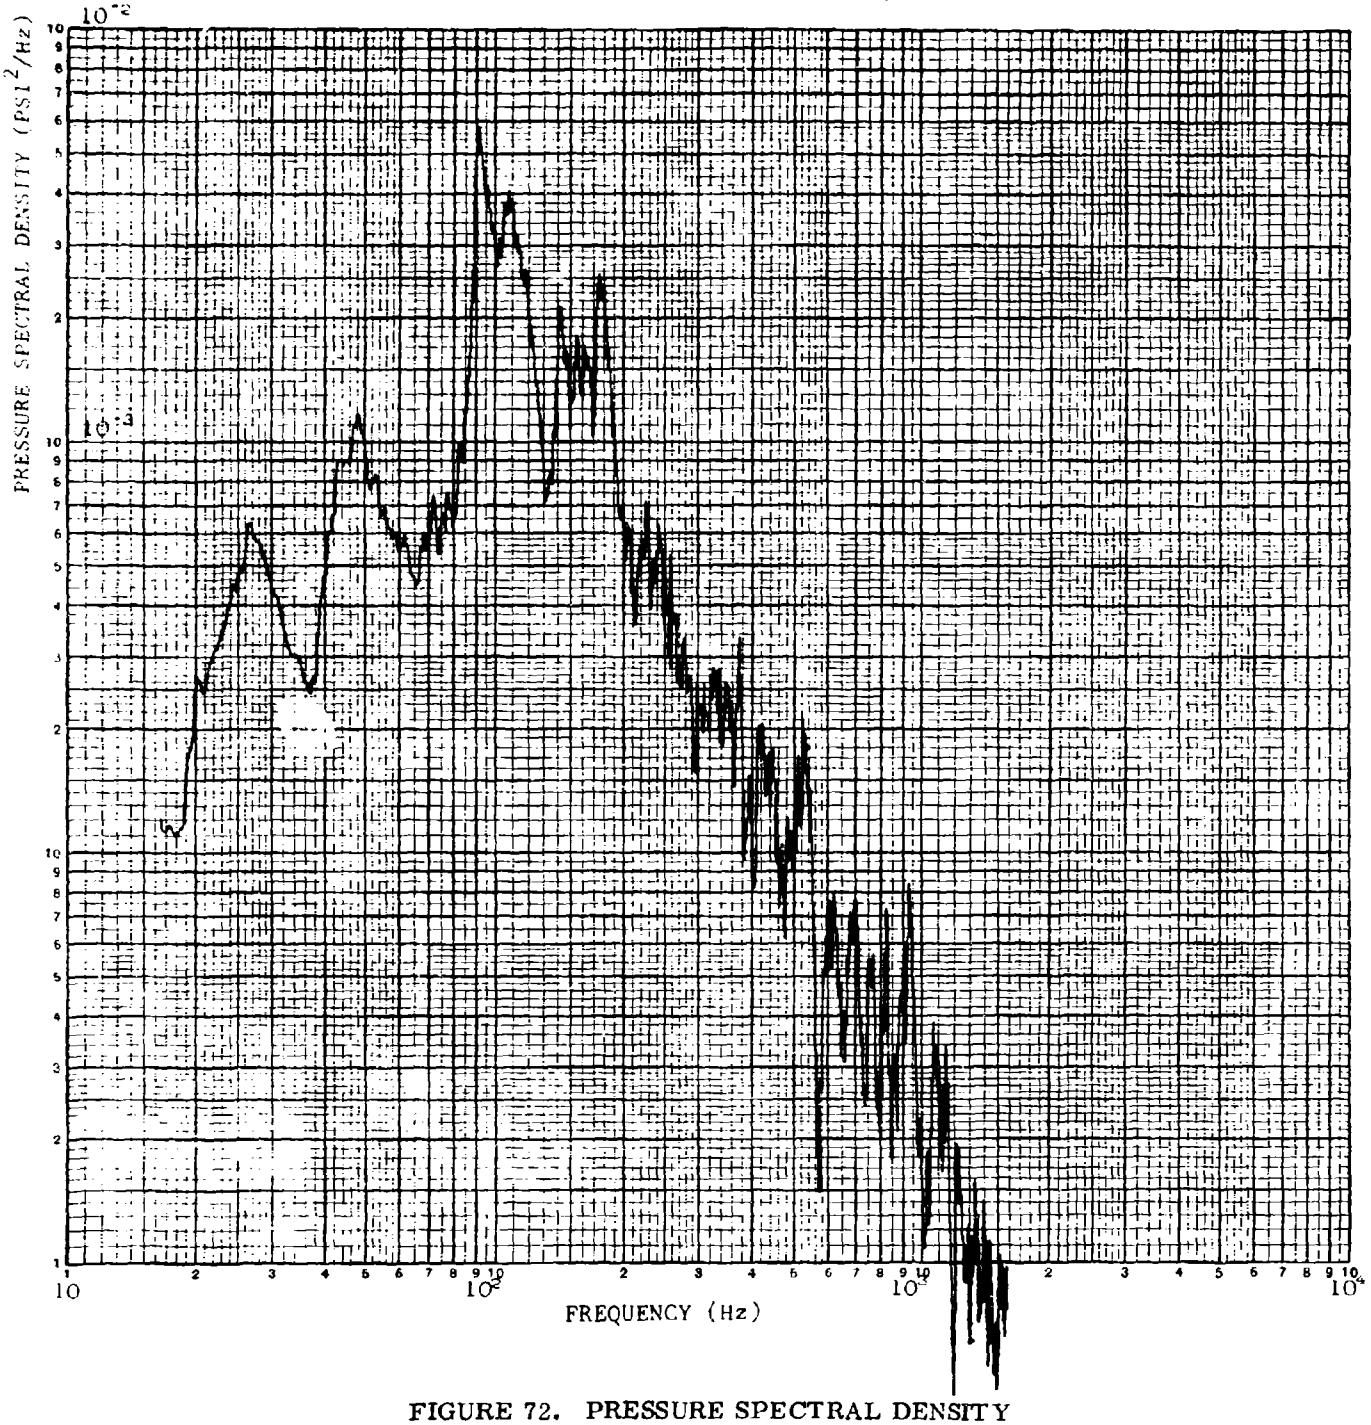
FIGURE 72. PRESSURE SPECTRAL DENSITY

From an examination of Figures 72 and 76 during the 166 db SPL run, the strain spectral density at strain gage No. 2 at 91 Hz is approximately equal to the strain spectral density at 290 Hz which is the lowest natural frequency. The spectral shape of the strain response in the neighborhood of 91 Hz is characterized by its similarity to the shape of the spectral density of the acoustic pressure (Figure 72) whereas the spectral shape of the strain response at 290 Hz is characterized by its similarity to the resonant response of the single degree of freedom spring-mass-dashpot system.

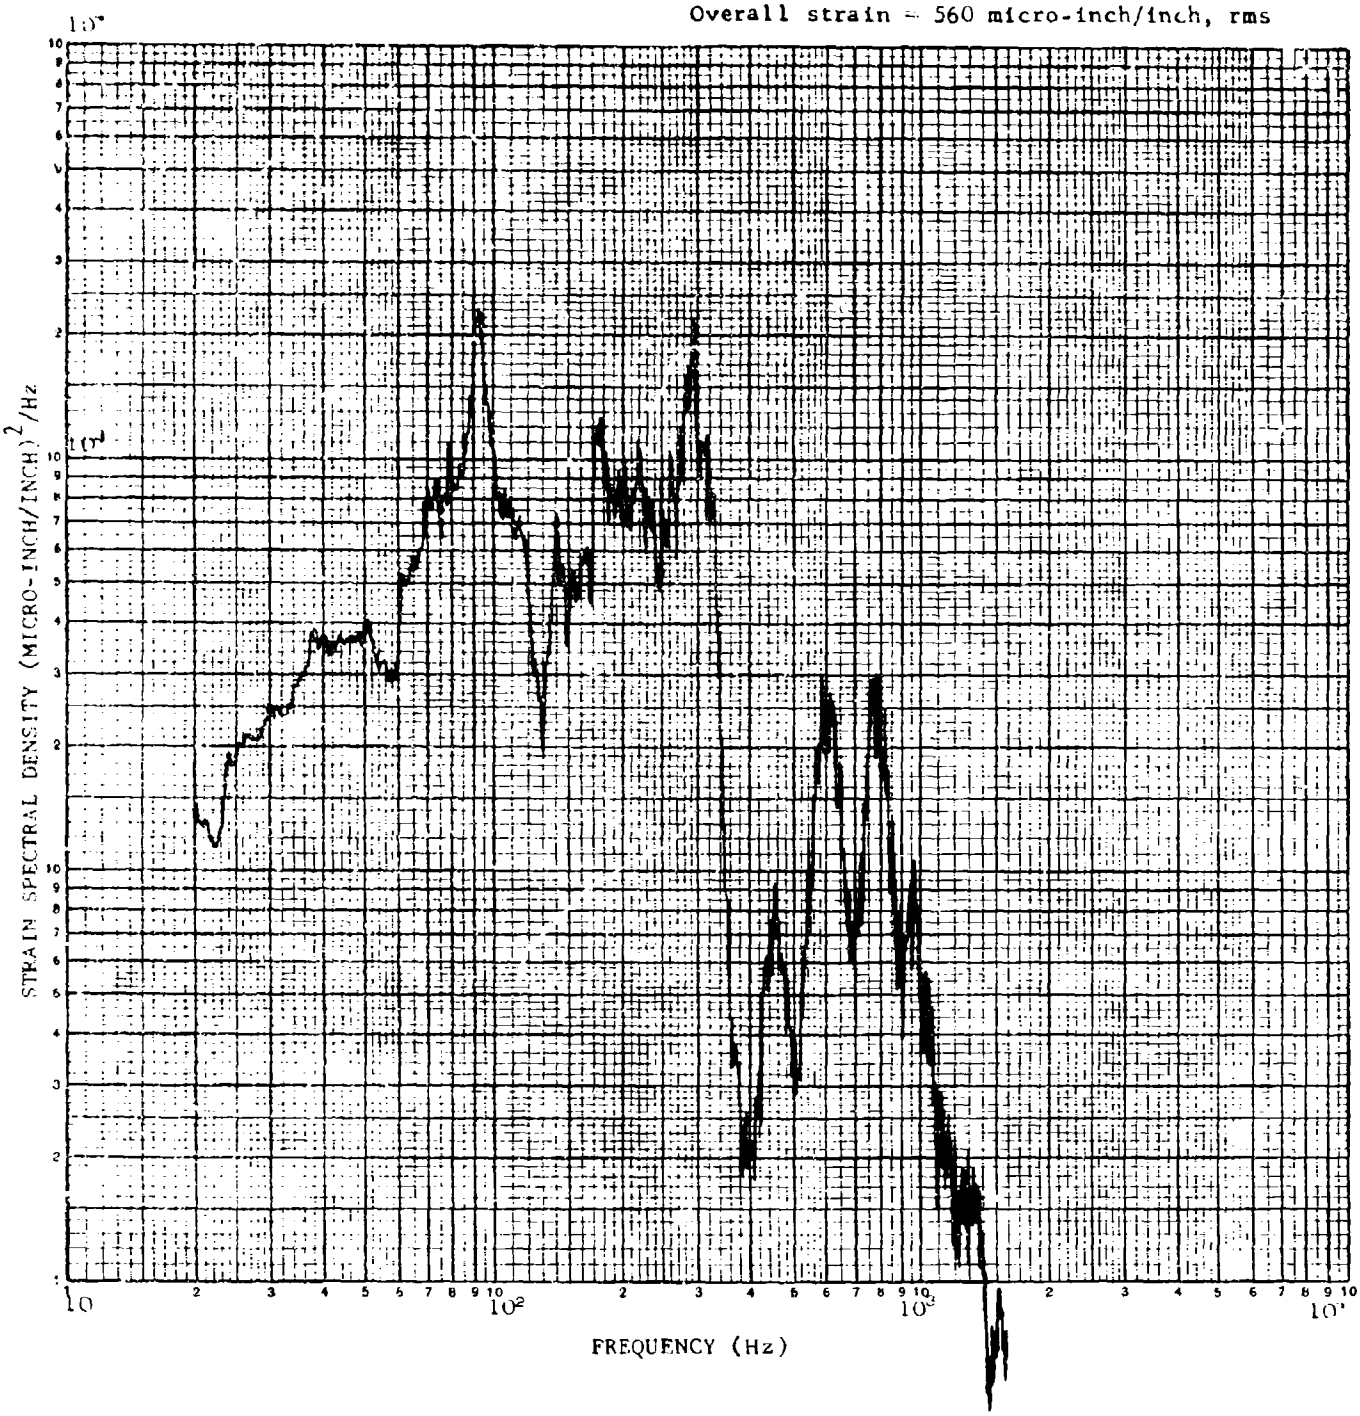
FIGURE 76. STRAIN SPECTRAL DENSITY

An examination of Figures 73 through 76 shows that the lowest natural frequency increases as the pressure applied to the panel is increased. Under loud-speaker excitation, the lowest natural frequency in Table IX was at 174 ±5 Hz. Under the acoustic pressure in the progressive wave test chamber, the lowest natural frequency in Figures 73 through 76 increased from 200 Hz to 290 Hz as the SPL was increased from 139 db to 166 db. The increase in natural frequency with increasing pressure is attributed to large deflections that result in membrane stresses that become increasingly significant relative to the bending stresses. The similarity of the pressure PSD and the strain PSD in the neighborhood of 91 Hz during the 166 db SPL run is also attributed to the increasingly significant membrane stresses relative to bending stresses as the acoustic pressure is increased.
